CULTURAL RESOURCE MONITORING AT
THE HENNY LANGER SITE (21CA58)

GULL LAKE, CASS COUNTY, MINNESOTA

Prepared by Barbara Withrow

August 25, 1983

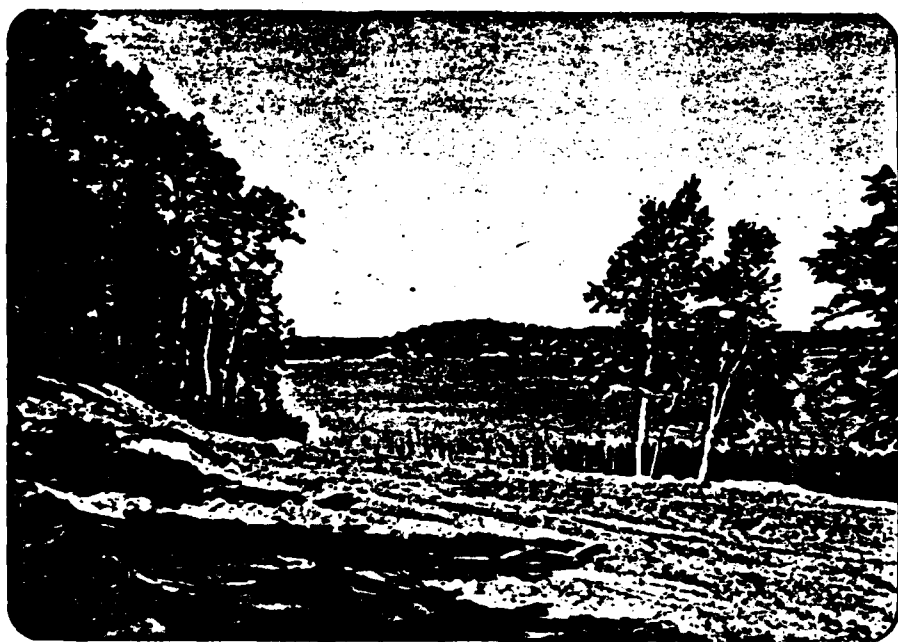
Photograph 5: Boat ramp

Boat Ramp (see photograph 5)

The future boat ramp is located at the west end of the main parking area (see figure 2). Construction of the boat ramp involved tree and stump removal, heavy bulldozing, and grading. No features were observed and no cultural material was collected from the boat ramp area. As indicated on figure 2, a second boat ramp was originally planned on the northeast side of the peninsula but was later omitted.
